STATE OF CALIFORNIA
DEPARTMENT OF TRANSPORTATION
NEW TECHNOLOGY & RESEARCH PROGRAM
OFFICE OF INFRASTRUCTURE RESEARCH

**DEVELOPMENT OF QUICK CHANGE
BREAKAWAY SIGN SUPPORT SYSTEMS TO
BE USED AS AN ALTERNATIVE TO
INSTALLING SMALL WOOD POSTS IN
AUGERED HOLES IN SOIL**

1. REPORT NO. FHWA/CA/TL-98/14	2. GOVERNMENT ACCESSION NO.	3. RECIPIENT'S CATALOG NO.	
4. TITLE AND SUBTITLE Development Of Quick Change Breakaway Sign Support Systems To Be Used As An Alternative To Installing Small Wood Posts In Augered Holes In Soil.		5. REPORT DATE NOV. 2000	6. PERFORMING ORGANIZATION CODE

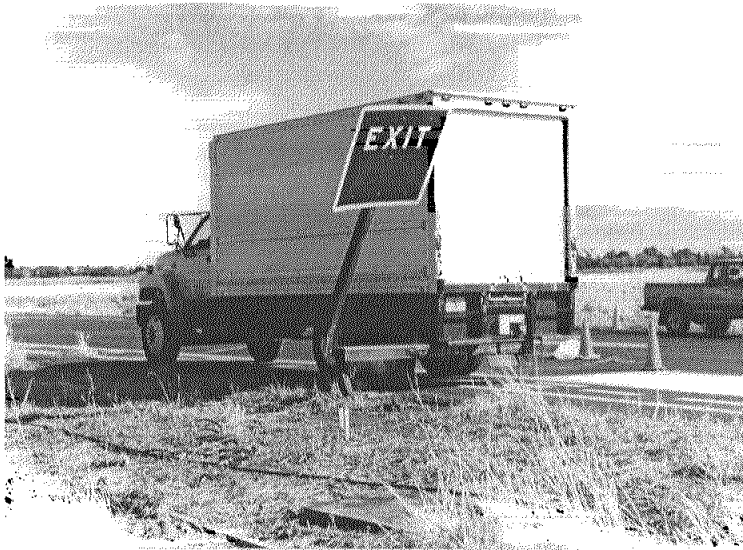
Figure 1. Dynamic knockdown testing of the prototype Quick Change Sign Post footing with a G84 EXIT sign mounted on a 4" x 6" wood signpost with break-away holes. Vehicle speed is 22 mph.

The tests consisted of hitting the posts approximately 18 inches above grade with a 203.2 mm x 152.4 mm x 8 mm thick wall, structural steel tube, 3.0 meters long. The tube was attached to the back of an 11,770 kg truck and cantilevered 1.57 meters out on the drivers side. The tube used a shear pin located 1.37 meters from the pivot point on the passenger-side end of the tube, see Figure 1, as a safety device to prevent damage to the tube or vehicle during a severe impact. On October 29, 1996, a number of different post configurations were hit using this vehicle, mounted tube, see Appendix D. A speed trap and set of tape switches were used during the knockdown tests to accurately determine the vehicle speed at impact.

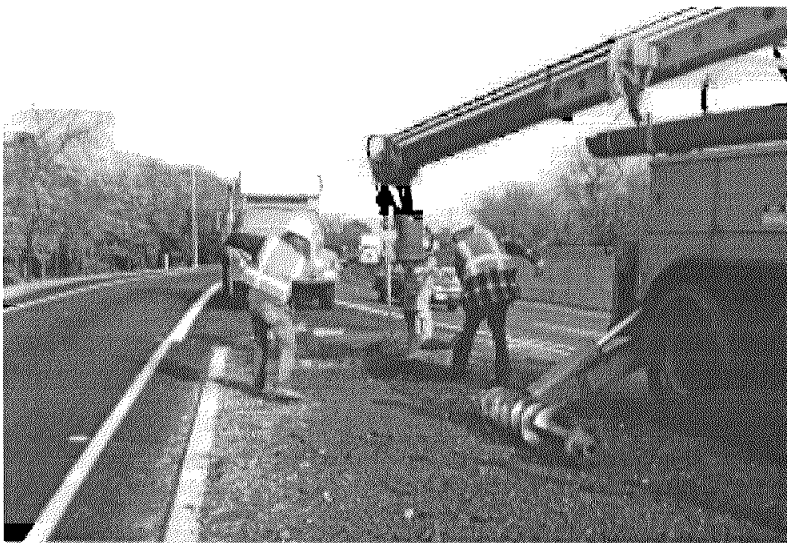
Figure 6. Augering a 24” diameter hole for initial installation of a quick-change signpost footing. Note that the crew is scattering some of the excess native soil during the augering operation.

1. Position and level the auger truck.
2. Use an 18” (minimum) or a 24” (maximum) auger bit, see Figure 6. The larger bit (24”) will make tamping around the installed footing easier.

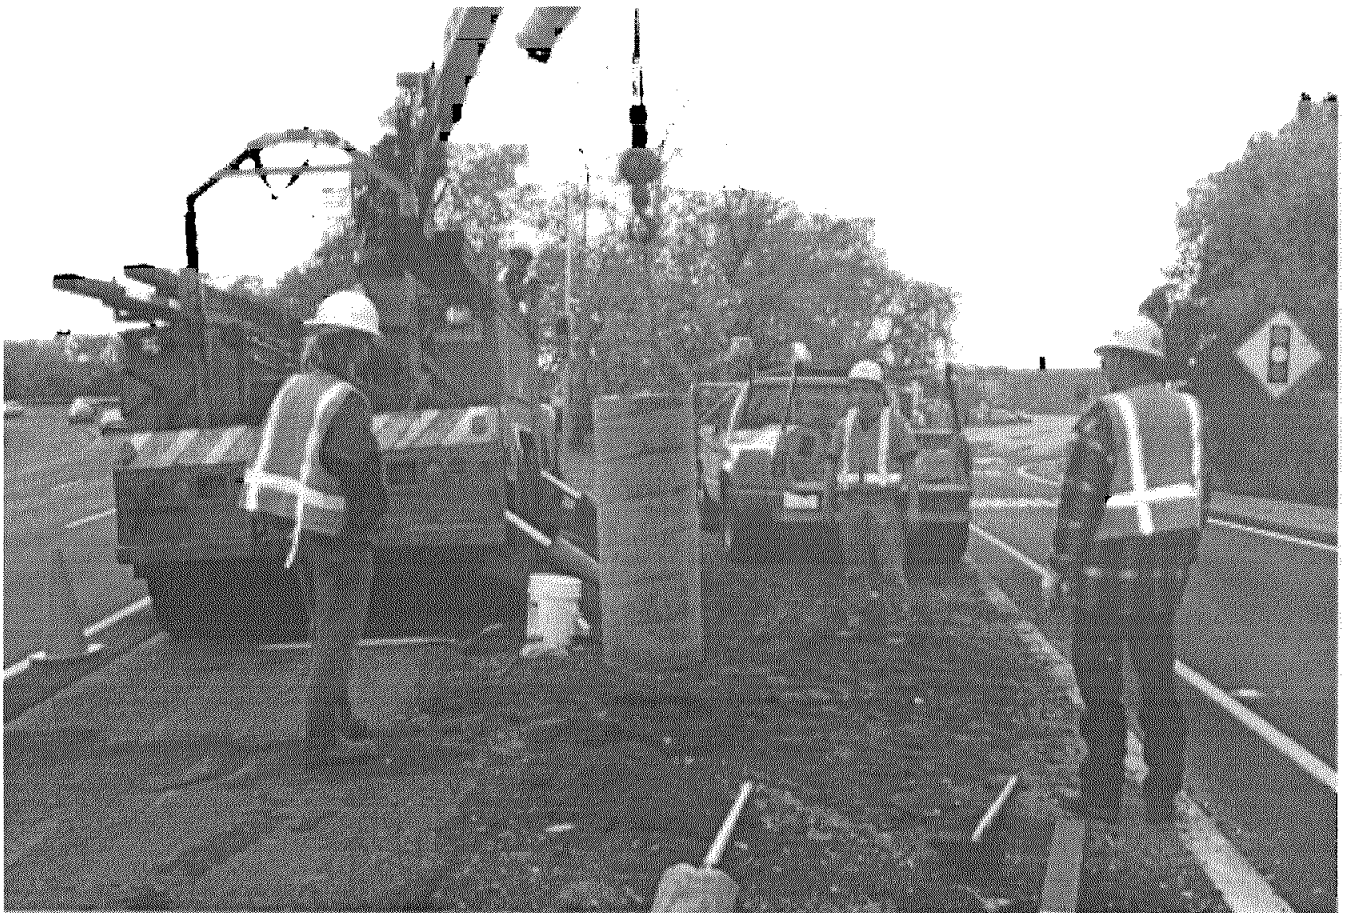
Figure 7. Lowering the footing into the augered hole.

9. Lower the footing into the hole taking care not to knock an excessive amount of native soil into the hole, see Figure 7. Before the footing is lowered completely, make sure the embossed arrow on the top surface of the footing is pointing in the same direction as traffic flow. This is to ensure proper orientation of the wedges.

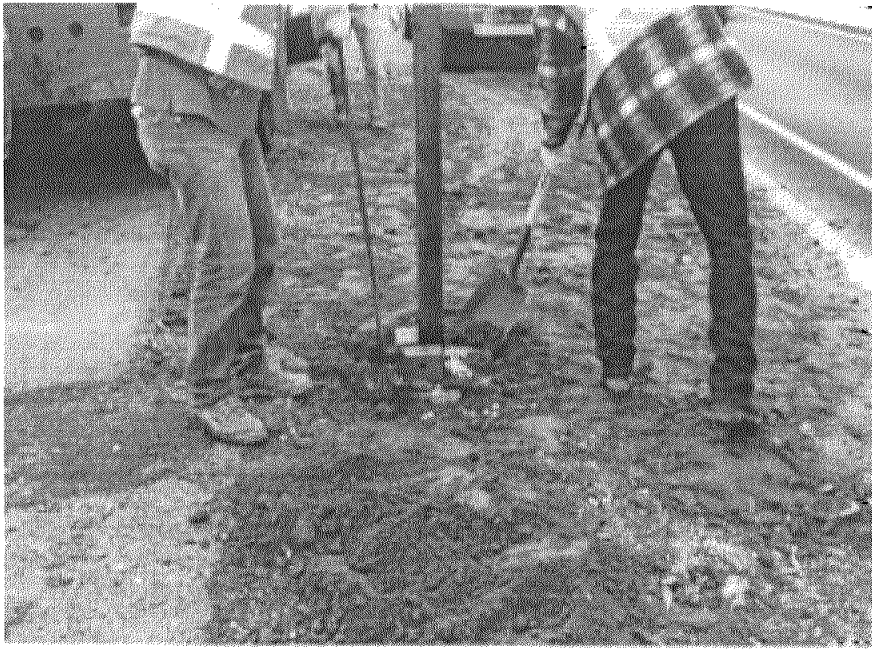
Figure 10.
Final backfilling and
tamping. (Looking in the
direction of traffic flow at
a gore point)

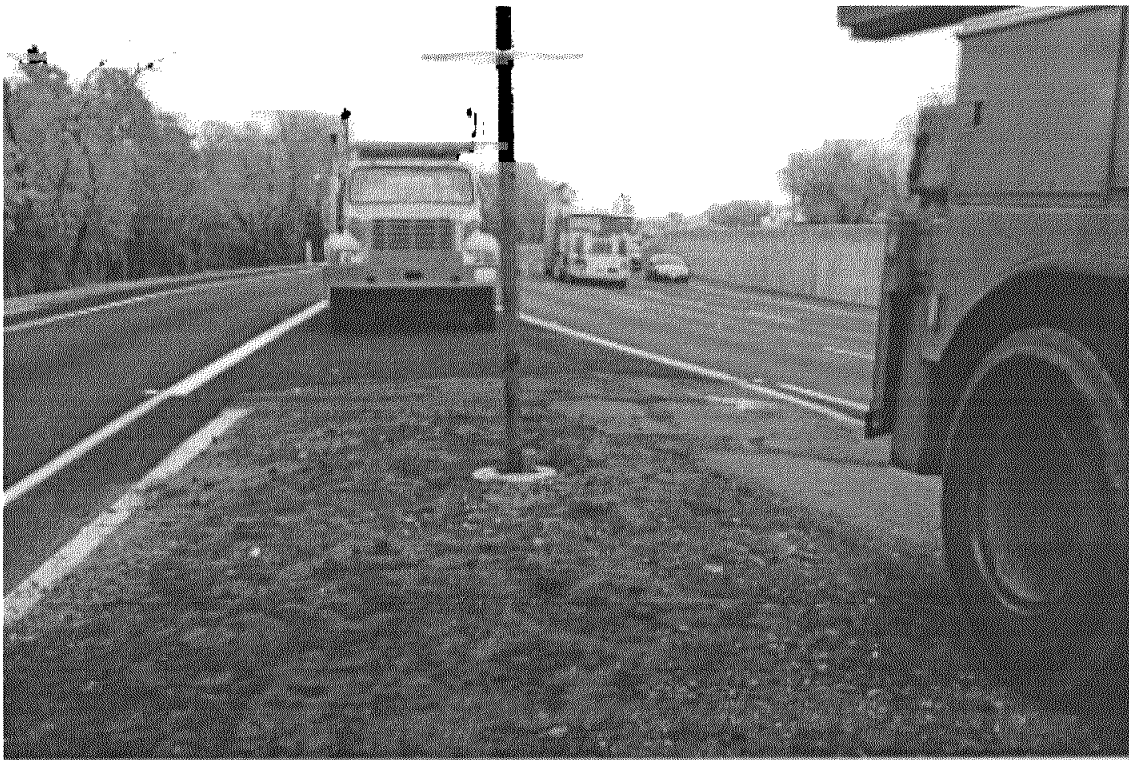
Figure 11. Footing installation completed.

13. Check that the footing is close to plumb and that it is properly oriented with the traveled way.
14. Using a (torpedo) level, have one person hold the post/footing plumb, (a slight tilt toward oncoming traffic may be desirable), while another uses native soil to backfill around the footing and tamp it down. This should be done in approximately 8" lifts, see Figure 10.
15. Once satisfied that the footing is properly and securely installed, lightly hammer the wedges down or merely step on them with full body weight to seat them. **DO NOT USE EXCESSIVE FORCE OR A LARGE NUMBER OF HAMMER BLOWS.** (This is unnecessary and will only make removal difficult)
16. Spread the unused native soil in a manner that will not pose a threat to motorists. Do not leave it piled at the installation site, see Figure 11.

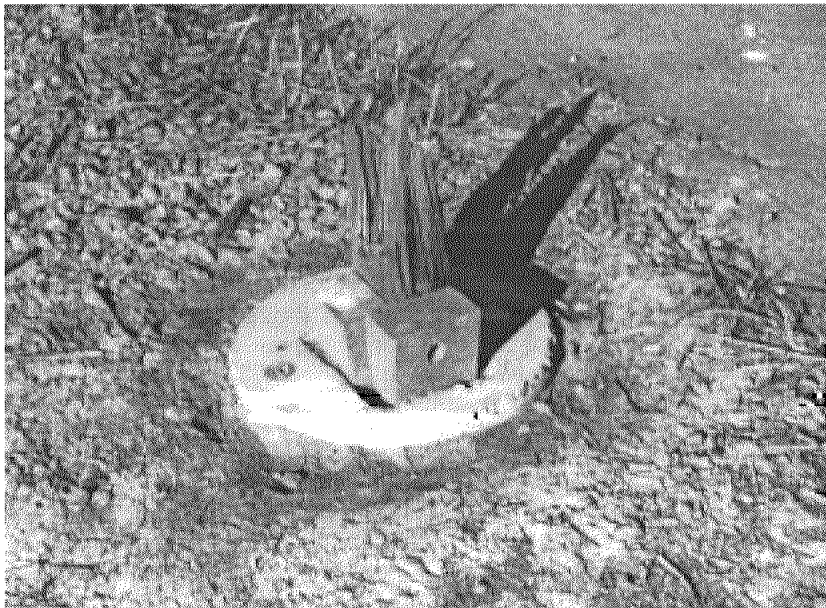
Typical result after a 4” x 6” signpost is impacted by an errant vehicle. Wedges are installed on the upstream side and the traffic-side.

1. Clear broken post debris from around the footing, see Figure 12.

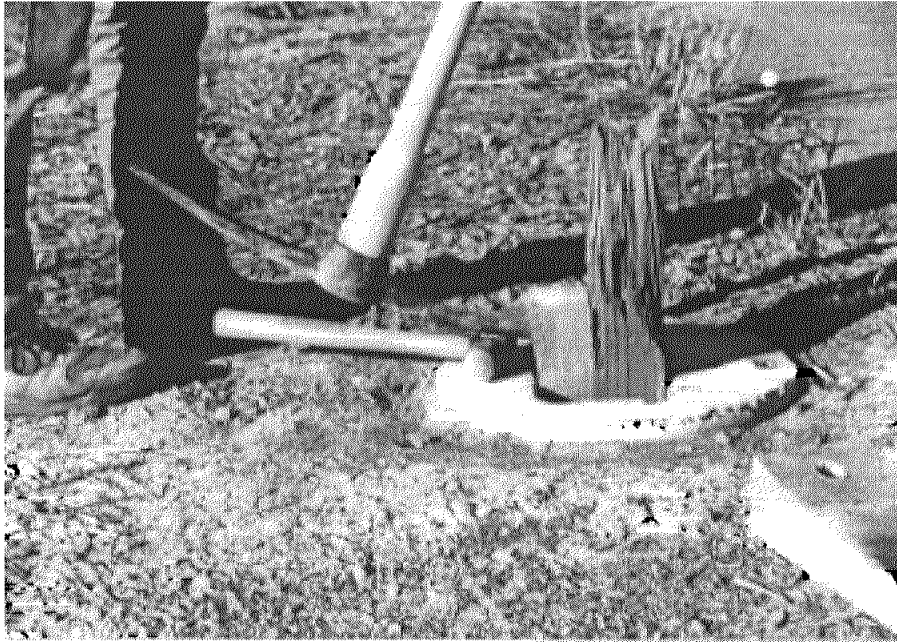
Figure 14.
Sledgehammer being used for leverage.

3. Tilt the pickax handle toward the center of the footing to allow placement of a 2 lb. sledgehammer head, (or other spacer material), between the head of the pickax and the top concrete surface of the footing. This is to provide leverage, see Figure 14.

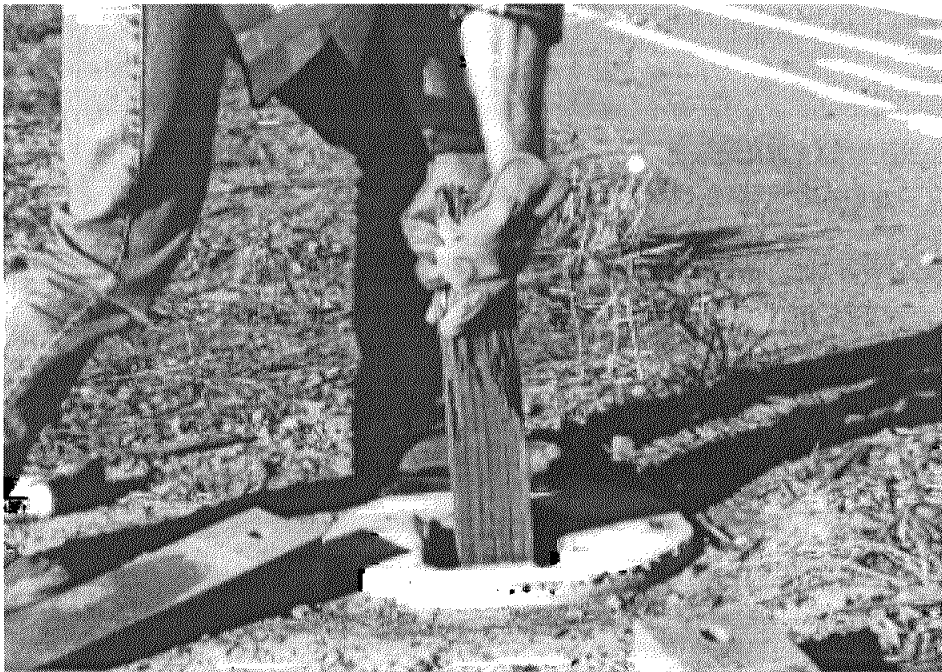
Figure 16.
Broken signpost
stub, being
removed from the
footing after
removal of the
wedges.

5. The wedge should pull free, sometimes suddenly.
6. If the wedge does not come loose easily, use another hammer to strike the sides of the wedge to help work it loose.
7. Again, apply pressure with the pickax. If the wedge does not come loose, you may have to strike the sides with one hammer while applying pressure with the pickax.
8. If the wedges cannot be removed using a pickax, use a hex bar and a piece of the broken post (for leverage) to remove the wedges using the same holes as above.
9. Once loose, remove the wedges and set aside. They will be re-used.
10. Grasp the broken stub with gloved hands and wiggle it until loose. Remove the broken stub from the cavity, see Figure 16.
